single-engine **SERVICE LETTER**

SE68-1

SUBJECT: FLAP ACTUATOR SLIPPAGE

MODELS AFFECTED: 150, 172/Skyhawk, 182/Skylane, Super Skylane, Super Skywagon, 210 Centurion, Turbo-System Super Skylane, Turbo-System Super Skywagon, Turbo-System Centurion

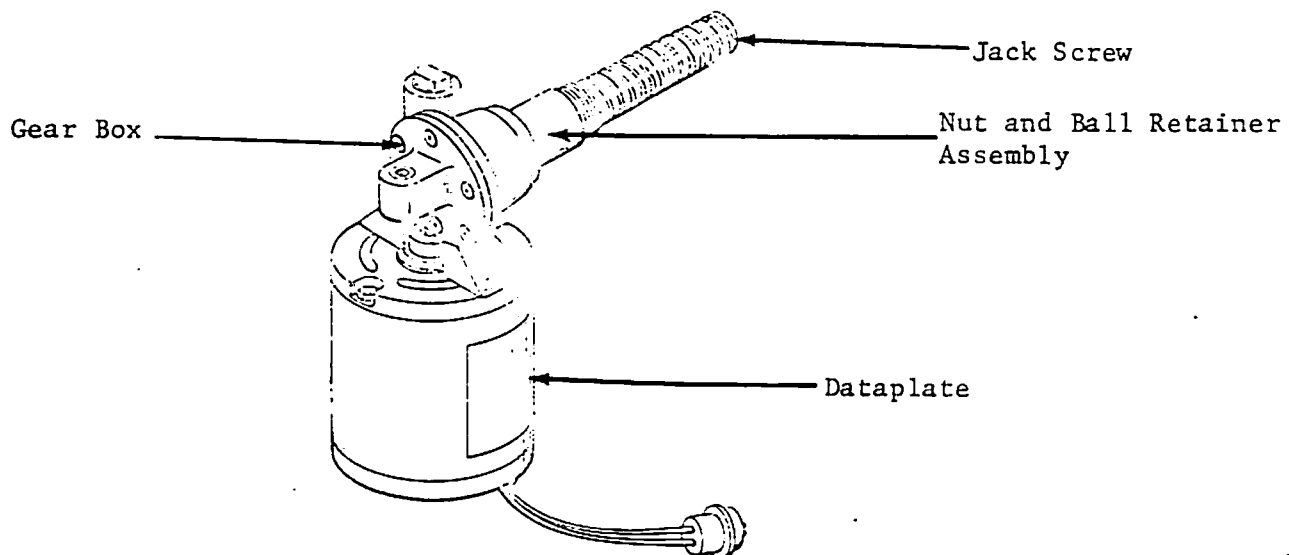
Service experience has shown that actuator slippage has been caused by a breakdown of the lubricant used on some of the actuator jack screws installed on the aircraft models shown above.

Since actuator slippage can result in wing flaps inadvertently retracting in flight, affected actuators must be inspected as soon as possible. Attached is a program showing aircraft affected and describes inspection and lubrication procedures.

- 2) Remove all existing lubricant from the jack screw:
 - a) Run the nut assembly to the end of the jack screw away from the gear box.
 - b) Soak the nut assembly and jack screw in a stoddard solvent.

- c) After soaking, clean the entire length of the jack screw with a wire brush, rinse with solvent, and dry with compressed air (Do not disassemble the nut and ball retainer assembly).
- 3) Relubricate the jack screw with MIL-G-21164 (Molybdenum Disulfide Grease) as follows:
 - a) Rotate the nut down the screw toward the motor.
 - b) Coat the screw and thread end of the nut with the grease and run the nut to full extension.
 - c) Repeat the process and pack lubricant in the cavity between the nut and ball retainer at the threaded end of the nut.
 - d) Repeat the process and work the nut back and forth several times.
 - e) Remove excess grease.
- 4) Reinstall actuator in aircraft.
